SUMMARY REPORT

Client: John and Denise Jones
Realtor: Phillip Marlowe, I Spy Real Estate
Inspection Address: 7575 W. Main St, Las Vegas, NV 89102
Inspection Date: 1/9/2011 Start: 9:00 am End: 11:00 am
Inspected by: Peter Hawley

GENERAL INFORMATION

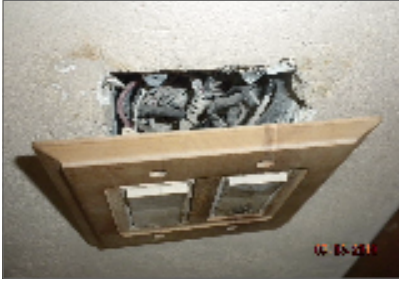
Outlets

The Inspector noted outlets that are not secure to the structures framing. Repair is recommended as a preventive fire and safety consideration.

- The Inspector noted outlets that are not secure to the structures framing. Repair is recommended as a preventive fire and safety consideration.

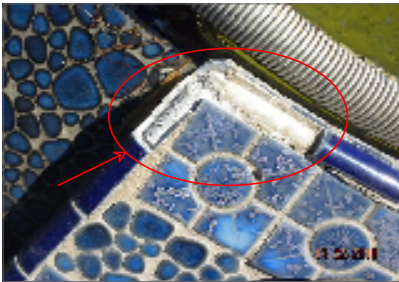
Tiles

There are several missing or damaged tiles at the waterline of the pool. These missing tiles can be a source of water loss from the pool and can lead to other more serious issues from the repeated water

- There are several missing or damaged tiles at the waterline of the pool. These missing tiles can be a source of water loss from the pool and can lead to other more serious issues from the repeated water
